## Toxic Levels of Lead and Copper in Groundwater Can Be Caused by Stray Electrical Current

by  
Todd Giddings, Ph.D., P.G.

NGWA Groundwater Week  
December 5, 2017  
Nashville, Tennessee

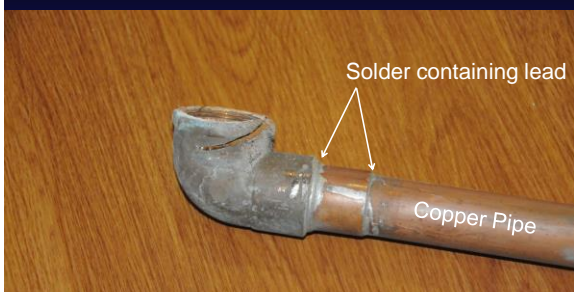
### The source is the piping in the building

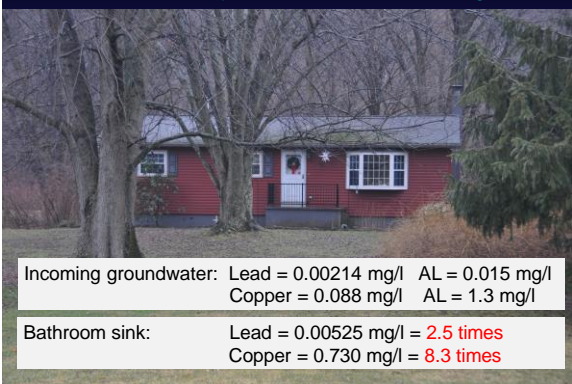
### A public water supply from a limestone spring

Incoming groundwater: Lead = 0.00214 mg/l AL = 0.015 mg/l  
Copper = 0.088 mg/l AL = 1.3 mg/l

Bathroom sink: Lead = 0.00525 mg/l = **2.5 times**  
Copper = 0.730 mg/l = **8.3 times**

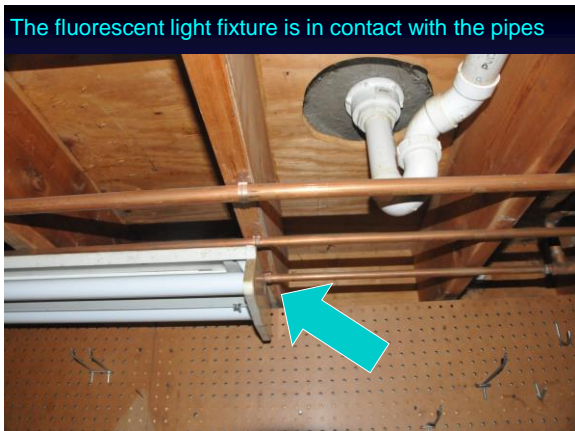
Before: Lead = 0.826 mg/l = 55 times the Action Level  
After: Lead = <0.008 mg/l Action Level = 0.015 mg/l
