## Toxic Levels of Lead and Copper in Groundwater Can Be Caused by Stray Electrical Current

by  
Todd Giddings, Ph.D., P.G.

NGWA Groundwater Week  
December 5, 2017  
Nashville, Tennessee

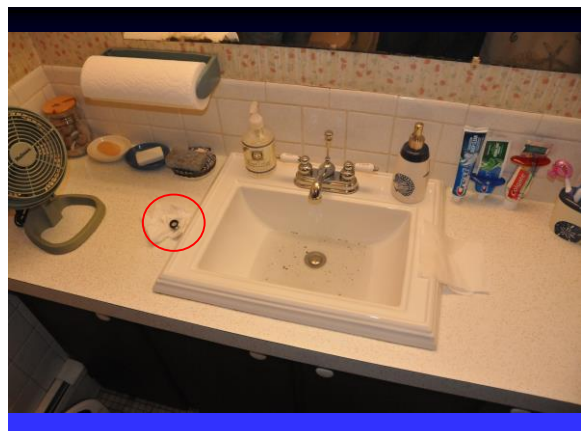
Incoming groundwater: Lead = 0.00214 mg/l AL = 0.015 mg/l  
Copper = 0.088 mg/l AL = 1.3 mg/l

Bathroom sink: Lead = 0.00525 mg/l = **2.5 times**  
Copper = 0.730 mg/l = **8.3 times**

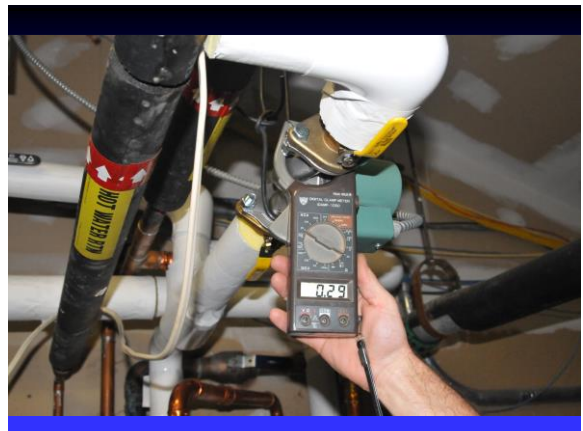
What is the impact of the stray electrical current?

First Draw water sample results:				
Building Name	Lead mg/l	Times Increase	Copper mg/l	Times Increase
Dormitory 1	0.016	>3.2	0.580	7.4
Dormitory 2	0.007	>1.4	0.746	9.6
Classroom 1	0.015	>3.0	0.595	7.6
Classroom 2	0.053	>10.6	0.986	12.6
Administration	0.397	>79.4	0.630	8.1
Incoming Groundwater	<0.005		0.078	
<b>Action Level</b>	<b>0.015</b>	3.0	<b>1.3</b>	16.7

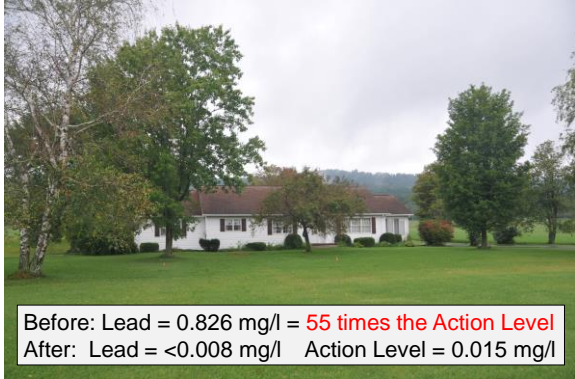
The spring water source is at the base of the ridge

Before: Lead = 0.826 mg/l = 55 times the Action Level  
After: Lead = <0.008 mg/l Action Level = 0.015 mg/l

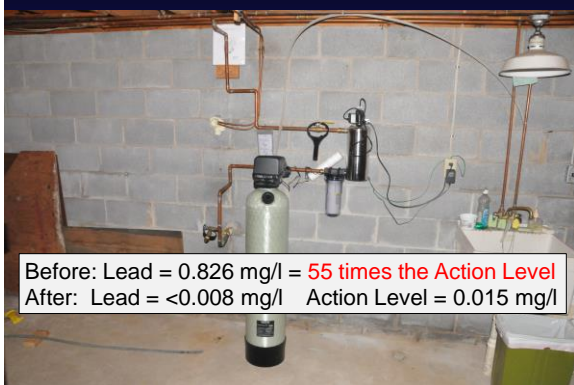
### The marble chips treat the aggressive spring water

The spring infiltration gallery is beneath the lawn
